Manhole Inspection Summary

Manhole # S49U1_006MH

Location Address: **3100 Frankfurst Ave.**

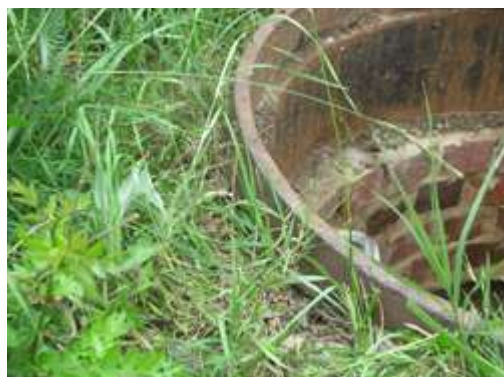
Defect 3

Cover Shape: **Circular** Diameter: **30** (in.) Length: (in.) Dist A/B Grade: **2** (in.)

Frame above the grade.

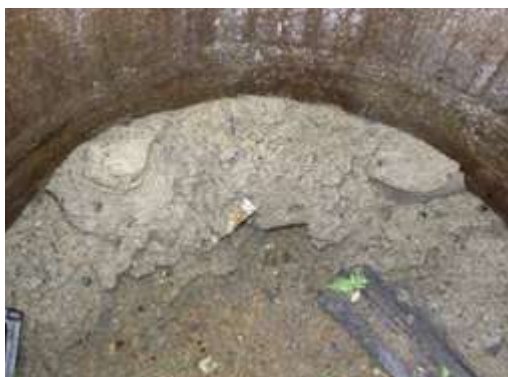
Defect 2

Debris on the bench.

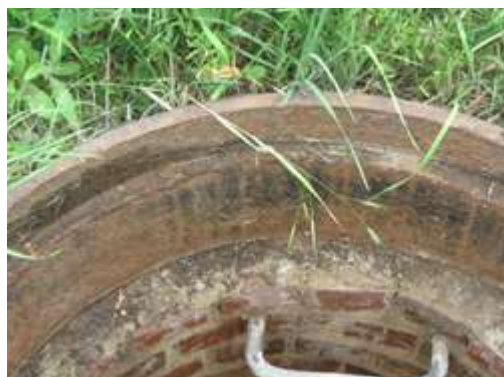
Defect 1

Frame Offset: **2.5** (in.) Condition: ☒ Sound ☐ Cracked ☐ Leaks

Frame offset

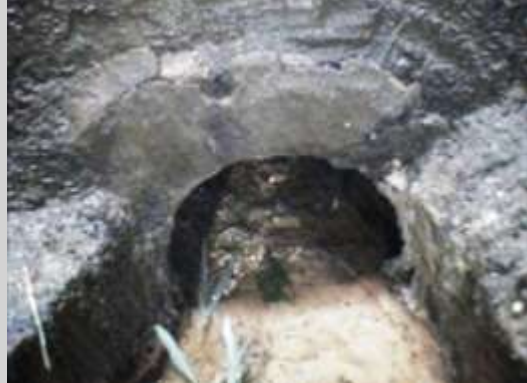
12 O'Clock Outflow

Pipe Height: **8.4** (in.) Rod and Bar (Angled)
Pipe Material: **Clay** ☐ Pipe Lined
Invert Depth: **12.70** (ft.) Flow Characteristics: **Slow**
Deposits: ☐ None ☐ Mud ☒ **Sludge** ☐ Debris ☐ Grease
Silt Depth: **3** (in.) Deposits Extent: **Medium**
Infiltration: **None** Pipe Seal Cond: **Sound**
